(14) NASL-9400-97-TM-11

(6) DEVELOPMENT
OF
INSPECTION PROCEDURES AND REPLACEMENT CRITERIA
FOR
AN/SQA-10 VDS TOWCABLES.

Lab. Project 9400-97, Technical Memorandum #11

(11) 19 SEP 66

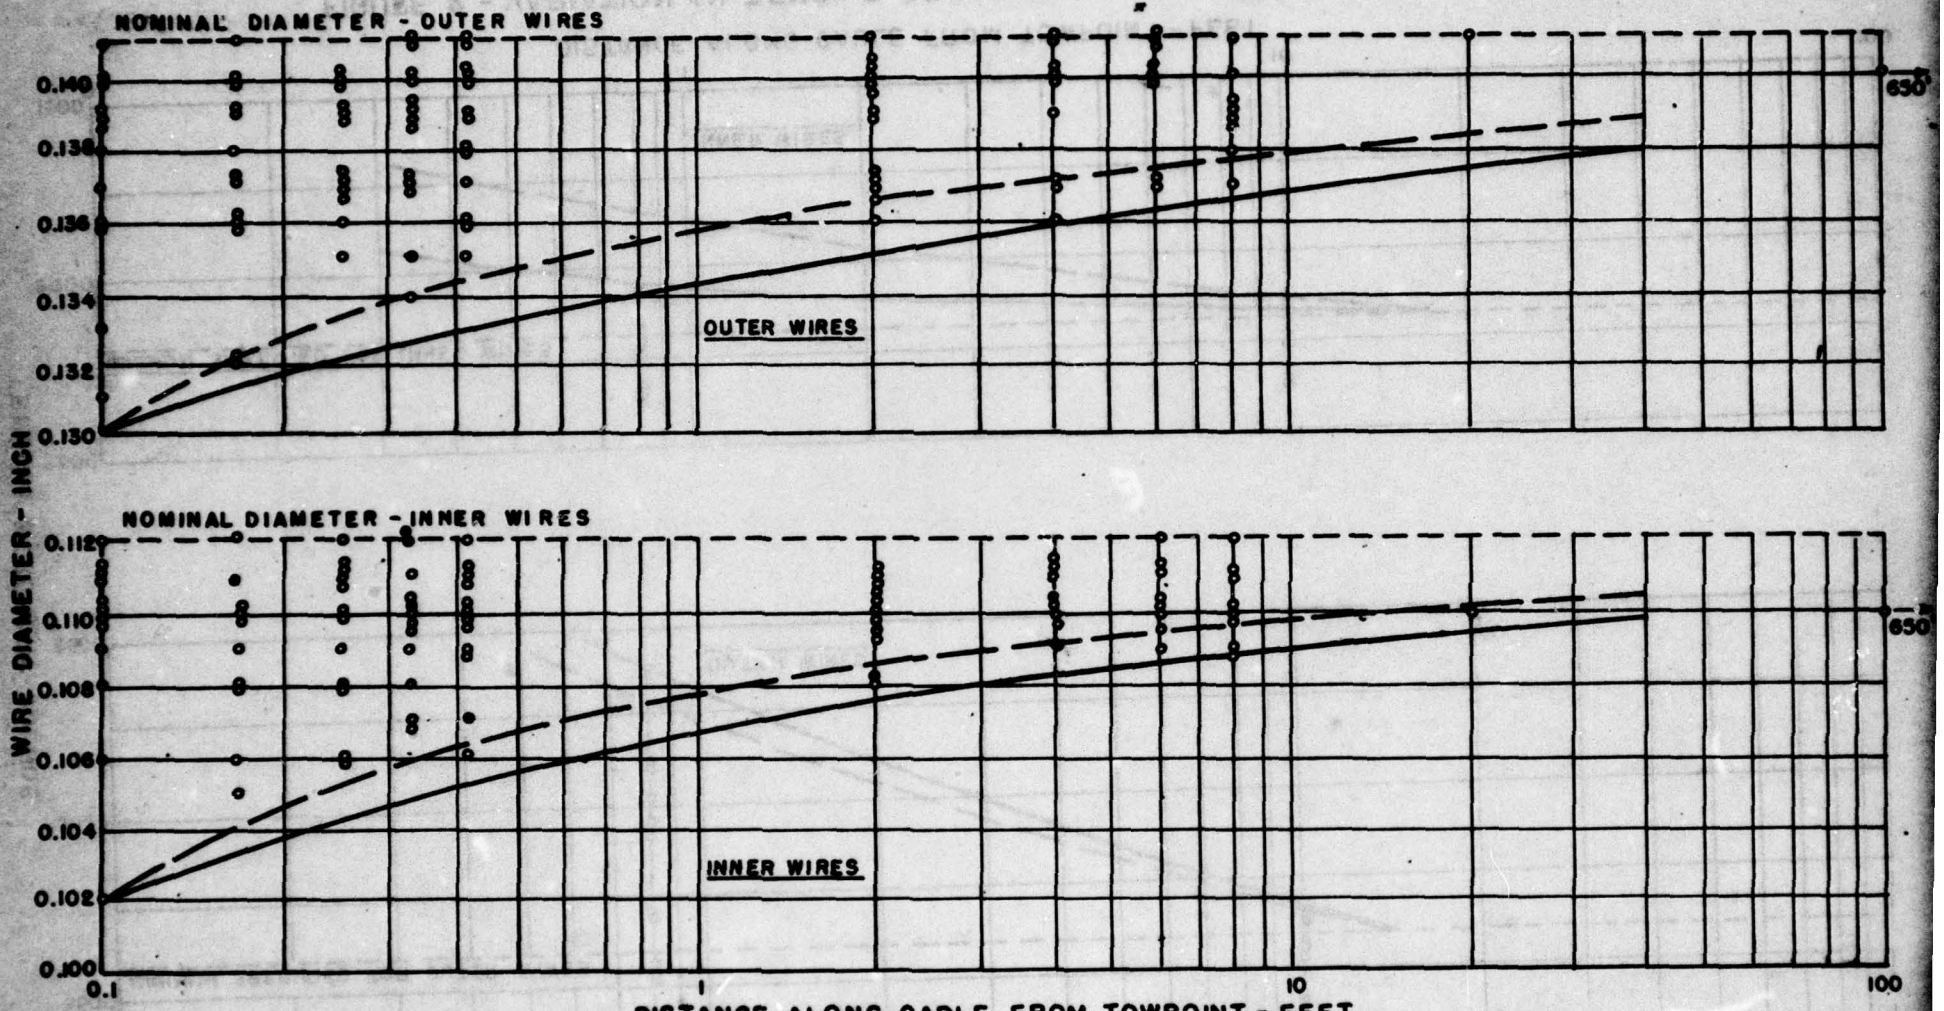
FIGURE 1 - VARIATION IN WIRE DIAMETER WITH DISTANCE FROM TOWPOINT FOR CABLES WITH UP TO 2 YEARS OF SERVICE

13. The data of Tables 2 and 3 for all cables with up to two years of total time in service are shown plotted on Figure 1 to show variation of corrosion along the cable as reflected by wire diameter. A curve is faired in through the lowest points plotted in order to reflect the worst conditions. It is seen that wire diameter reduction due to corrosion is a maximum of about 0.010 inch at the towpoint end and drops off gradually to about 0.004 inch at ten feet from the towpoint end. There does not appear to be any significant difference in corrosion of inner and outer wires as measured by reduction in wire diameter. The dotted curves, representing corresponding data reported in reference (b), indicate that the two sets of data have approximately the same trend.

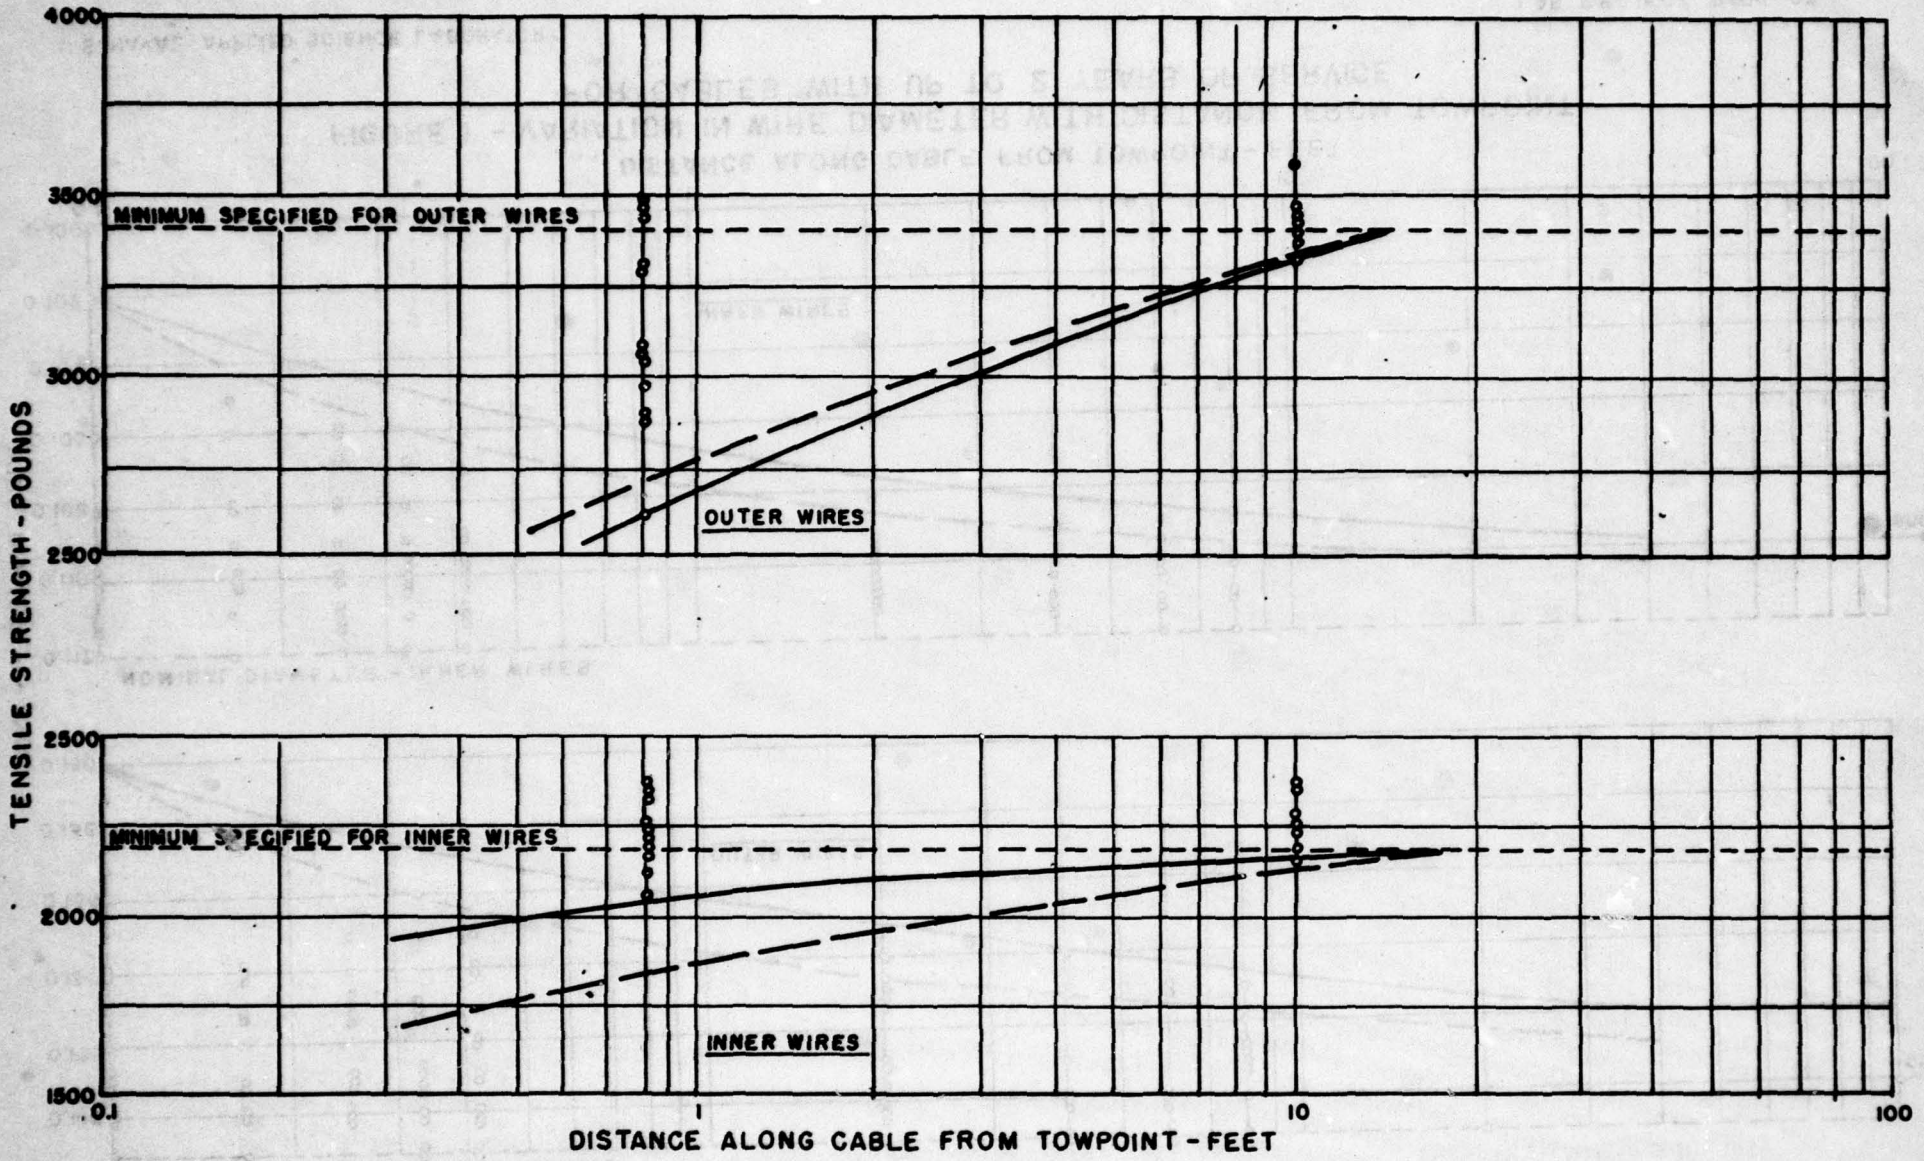
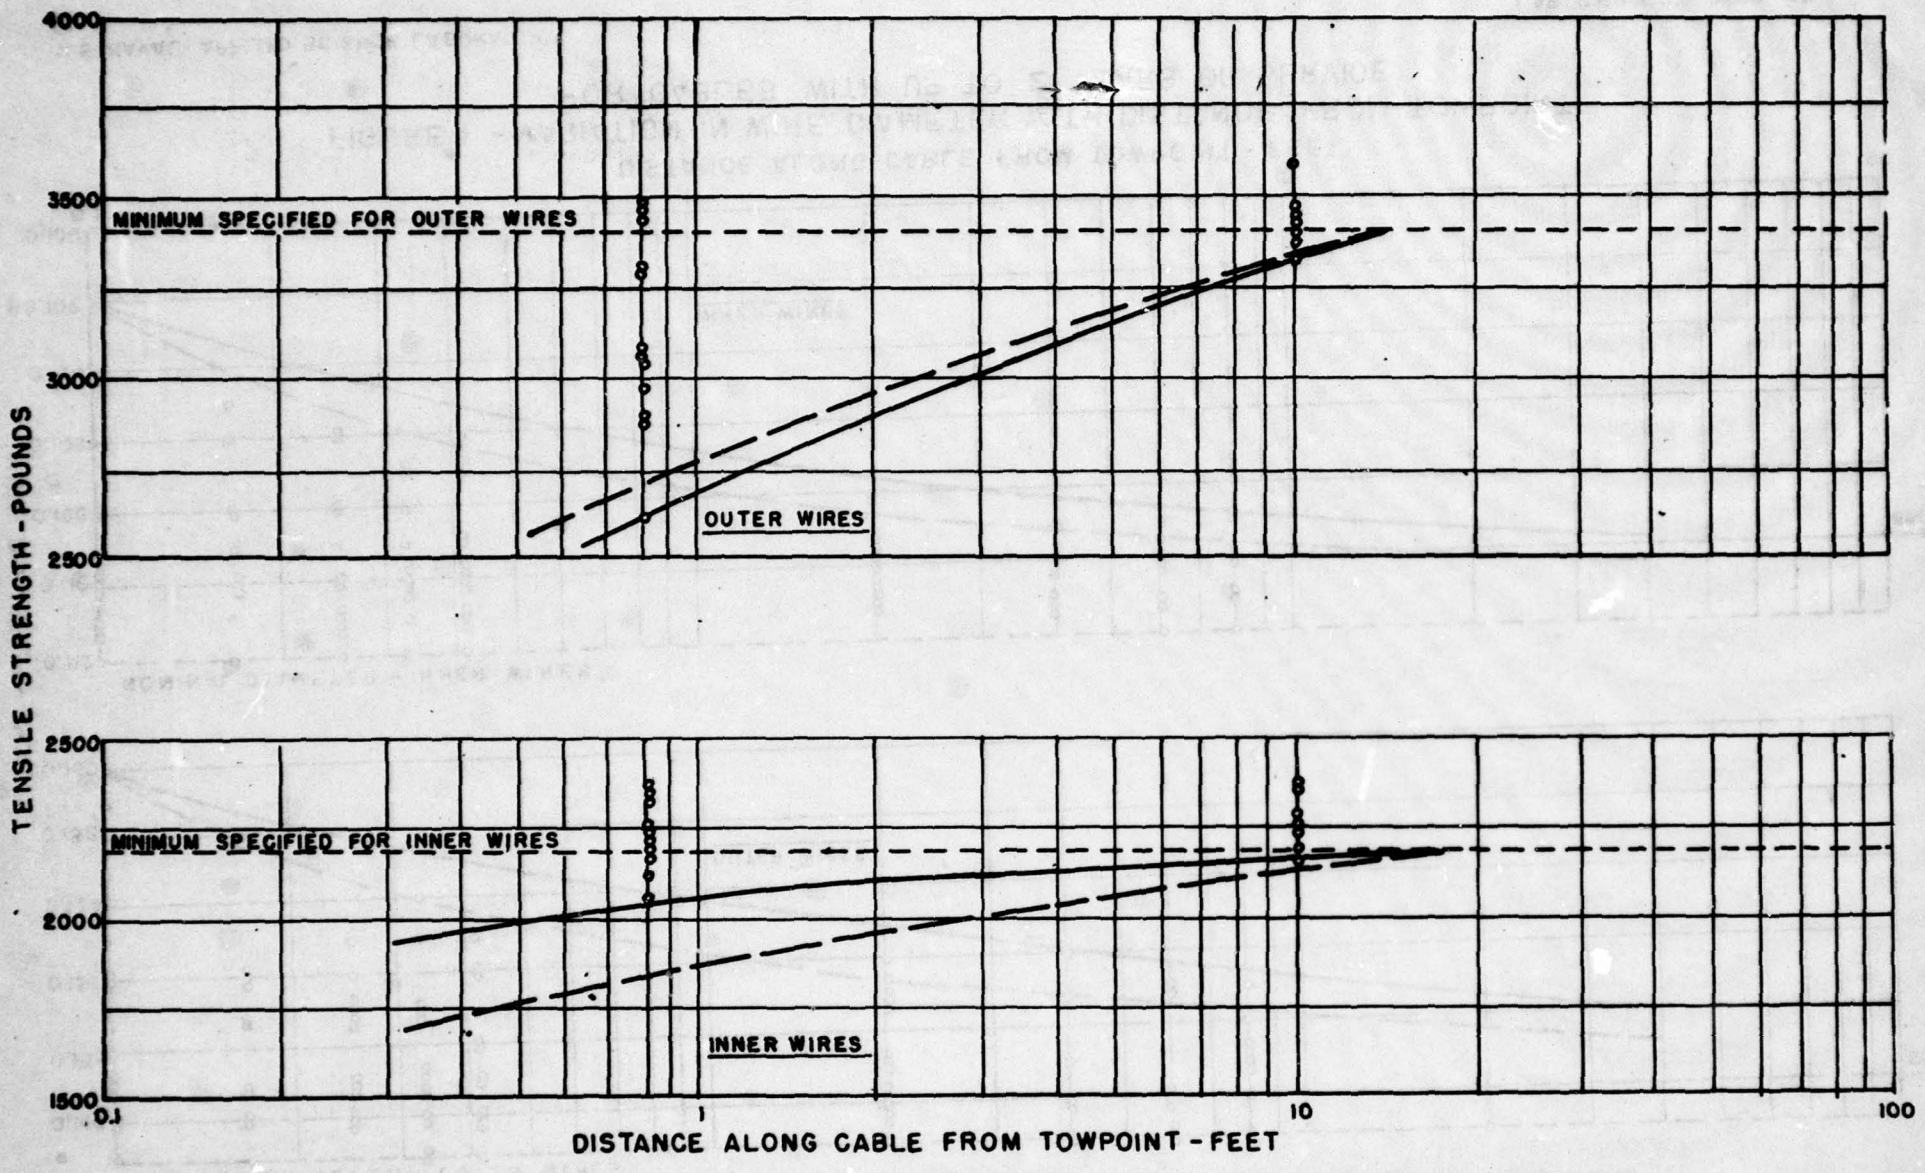
FIGURE 2 - VARIATION IN TENSILE STRENGTH WITH DISTANCE FROM TOWPOINT FOR CABLES WITH UP TO 2 YEARS OF SERVICE

14. The data of Table 4 for all cables with up to two years of total time in service are shown plotted in Figure 2 to show variation of tensile strength of wires with distance from towpoint. A curve is faired in through the lowest points plotted in order to reflect the worst conditions. It is seen from these curves that although tensile strengths at the towpoints are far below the minima specified for the wires, they increase rapidly with distance from the towpoint to the specified minima at a distance of approximately 10 to 15 feet. Here again, the dotted curves representing corresponding data from reference (b) indicate that the two sets of data have approximately the same trend.
